**Bundu Mining (Pty) Ltd:  
Annual Financial Rehabilitation Provision Plan -  
FY2024/2025  
GP10124 MR**

Report Reference – BM\_2024\_ARP

Report Date – October 2024

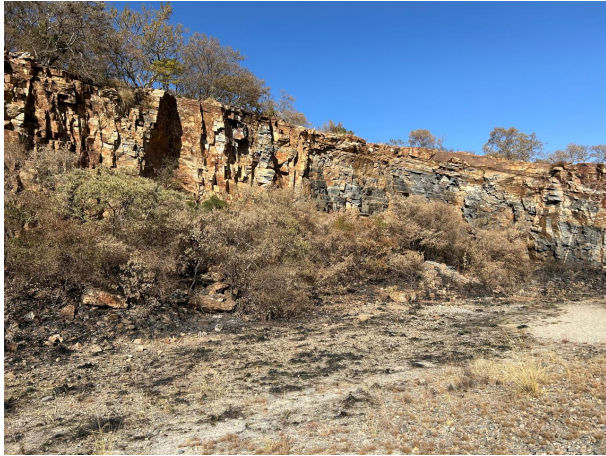
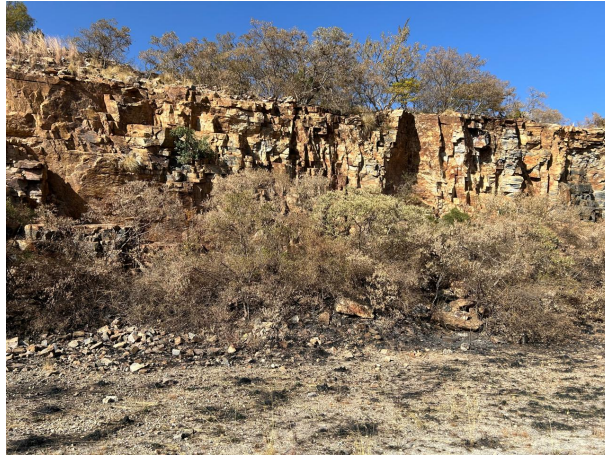
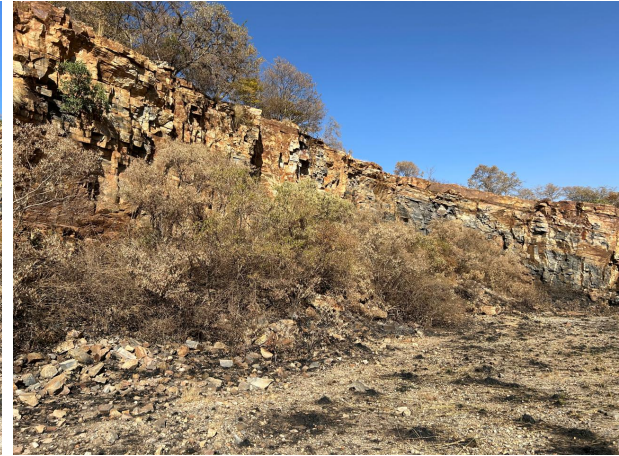
*Photo 1: Visual representation of current natural vegetation creating screen to disturbed area*
